Manhole Inspection Summary

Manhole # S31EE2017MH

Location Address: **5703 AINSLEY GRTH**

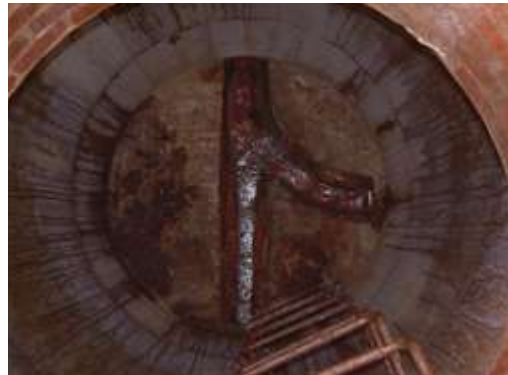
Top View

Bench debris.

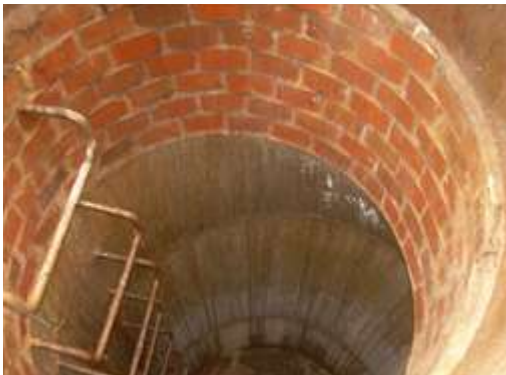
Defect

Adjustment and Corbel infiltration - other side.

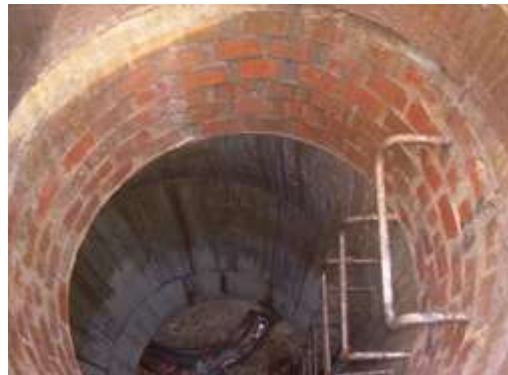
Defect

Adjustment and Corbel infiltration.

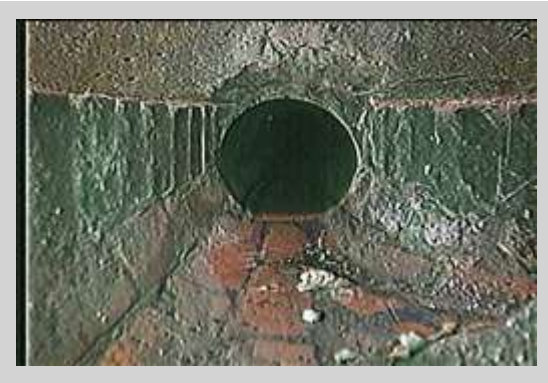
8 in. Circular Gravity Sewer Pipe Out @ 12 O'Clock

Channel deterioration.

Infiltration: **Evidence** Pipe Seal Cond: **Unknown**

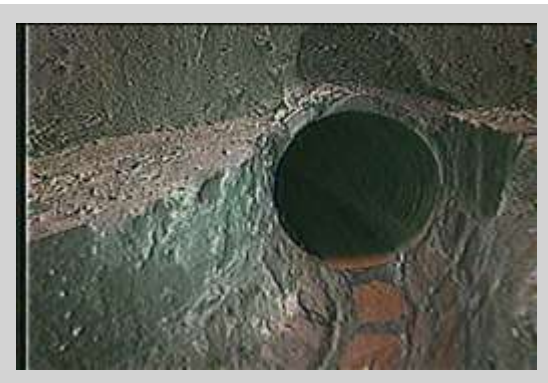
8 in. Circular Gravity Sewer Pipe In @ 3 O'Clock

Infiltration: **Evidence** Pipe Seal Cond: **Cracked**

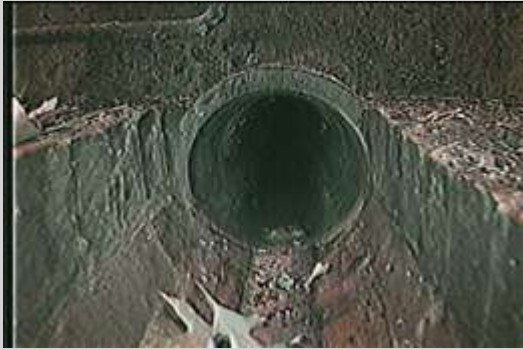
Pipe In @ 6 O'Clock

Deposits: ☐ None ☐ Mud ☐ Sludge ☒ **Debris** ☒ **Grease**

Infiltration: **Evidence**

Pipe Seal Cond: **Cracked**
